# *Hurricane Katrina – U.S. Gulf Coast – September, 2005*

## A photo tour of Hurricane Katrina

2001 Co. Wind Vented Roof System survives  
Hurricane Katrina winds and tidal surge.

**The Shoulder, Spanish Fort, Alabama**

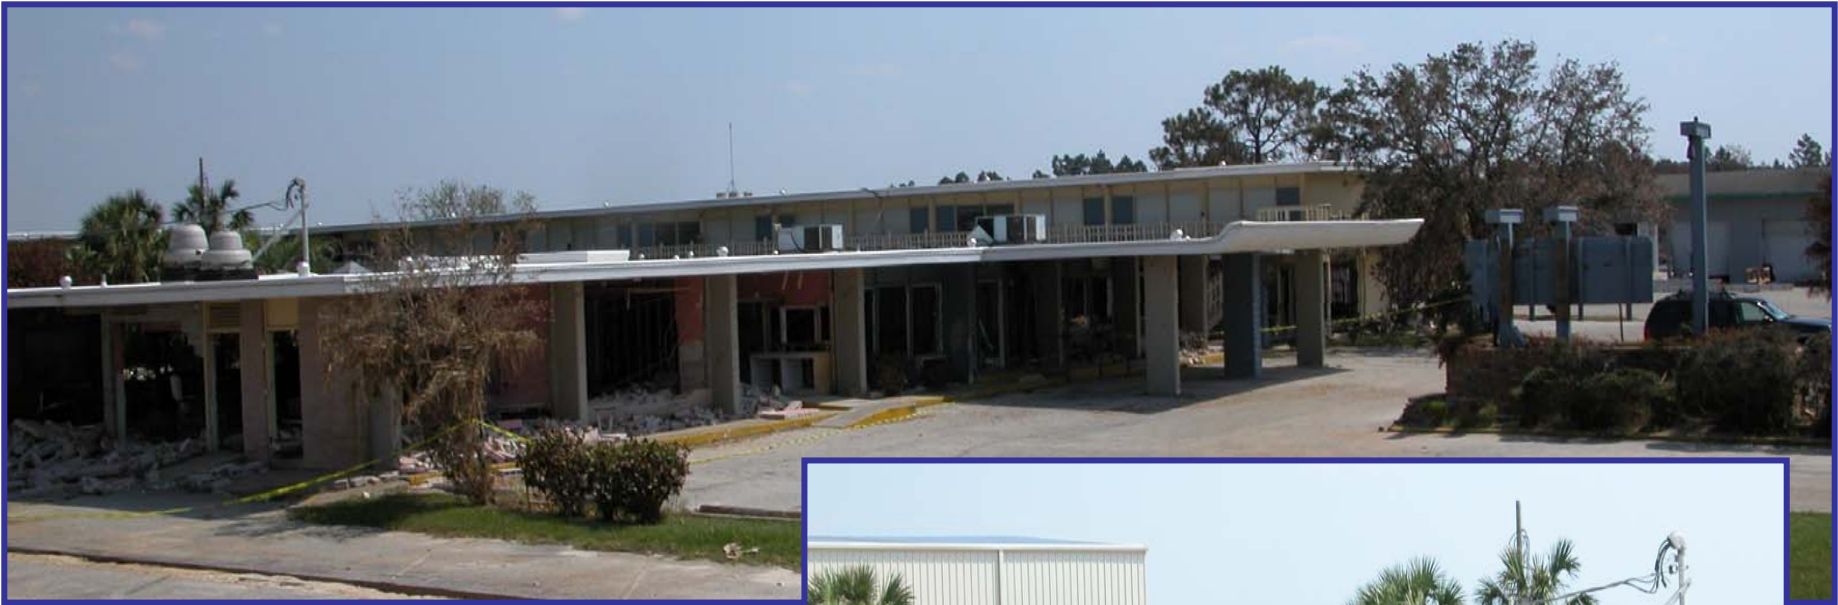
Experienced wind and tidal surge, Aug. 29<sup>th</sup>, 2005, but the 2001 Co. Wind Vented Roof stayed in place.

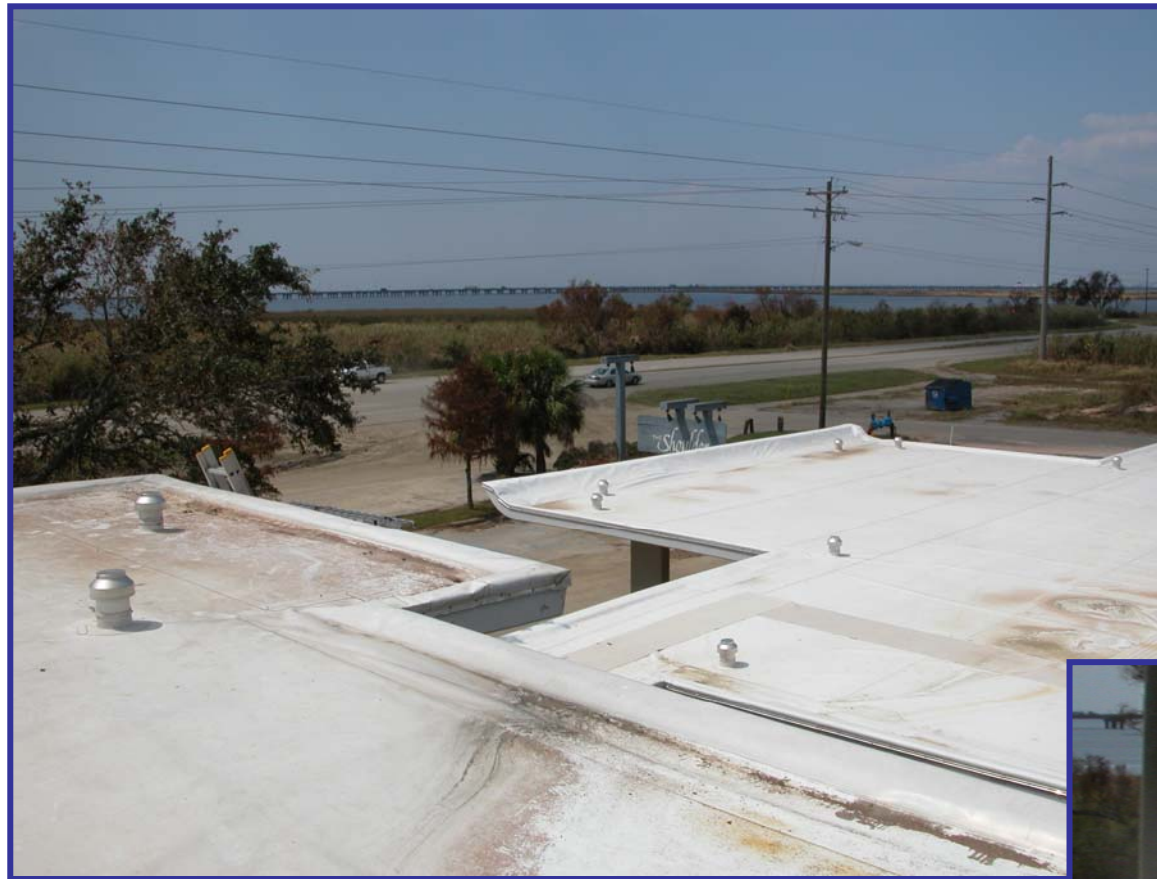
**The front of the facility overlooks Mobile Bay. The Interstate 10 viaduct across Mobile Bay is seen in the background over the grassy marsh lands. Battleship Parkway is the road seen in the front of the building.**

**The 2001 Co. Wind Vented Roof withstood Hurricane Katrina's Fury. Wind uplift vacuum forces are transferred through the equalizer valves placed on the corners and perimeters to hold the roof membrane in place during periods of high wind activity.**

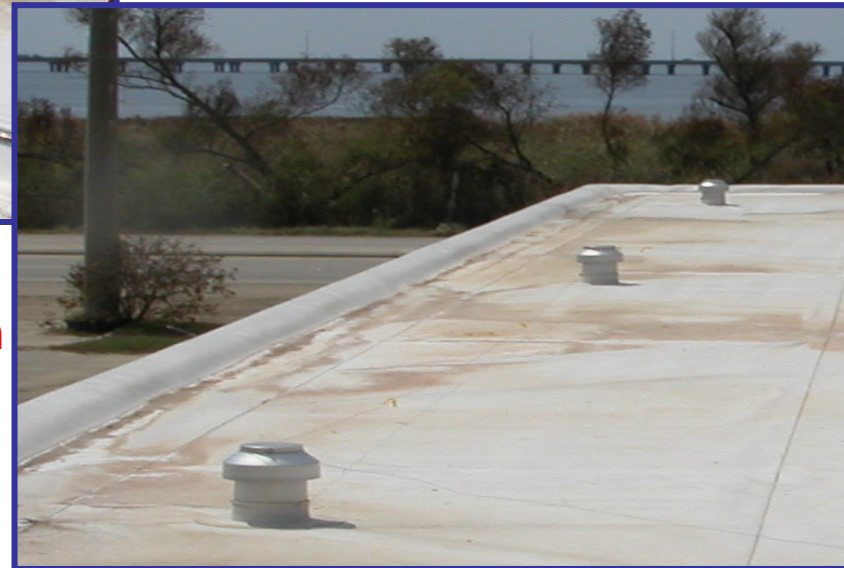
Windblown and tidal debris, spread out over the roof, clogged the drains. The roof's two inch raised gravel stop allowed excess water to flow off the roof.

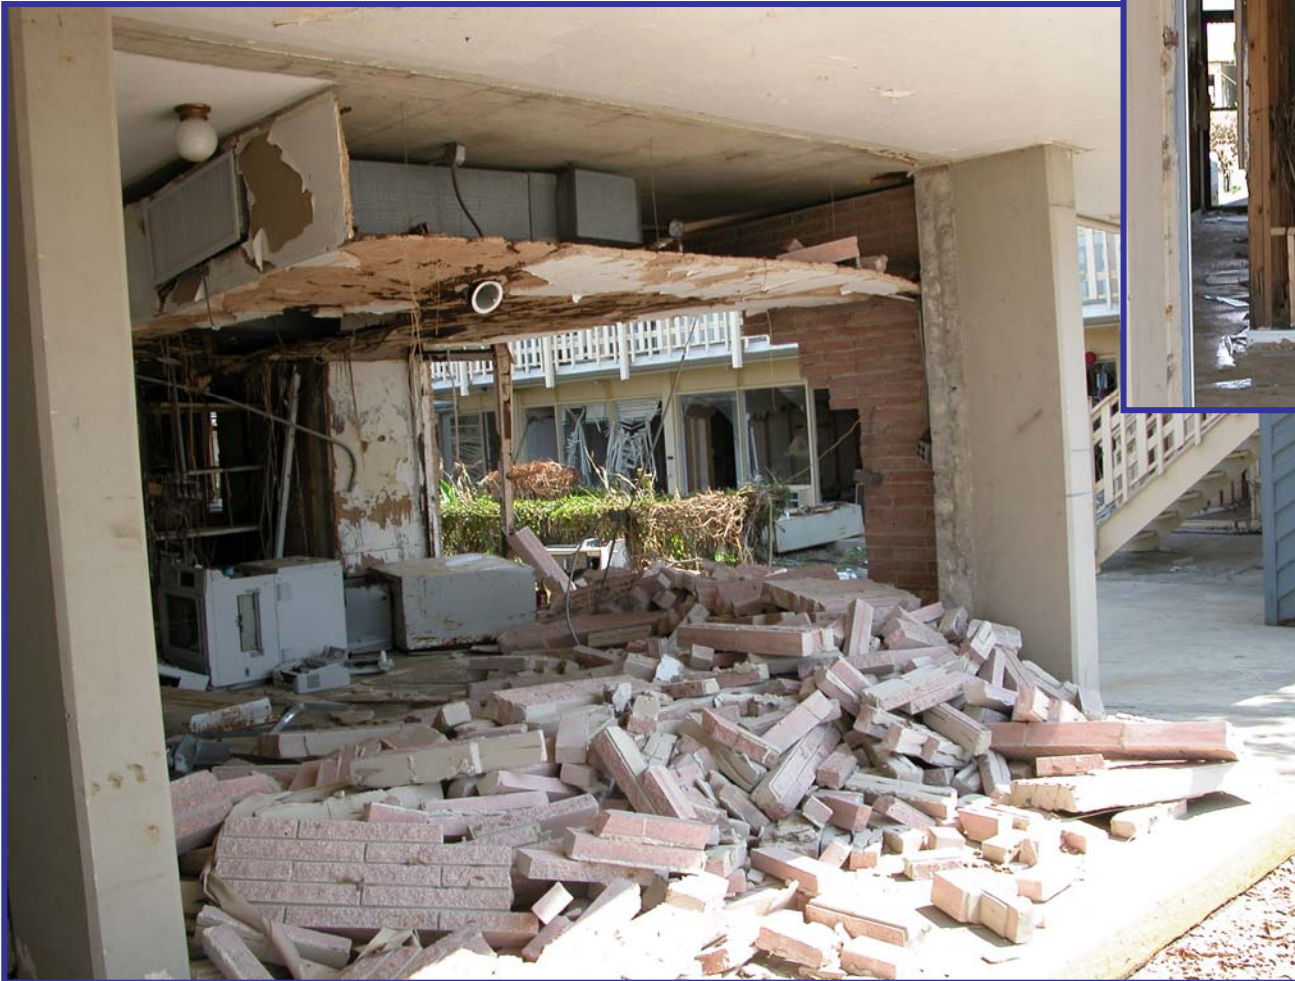
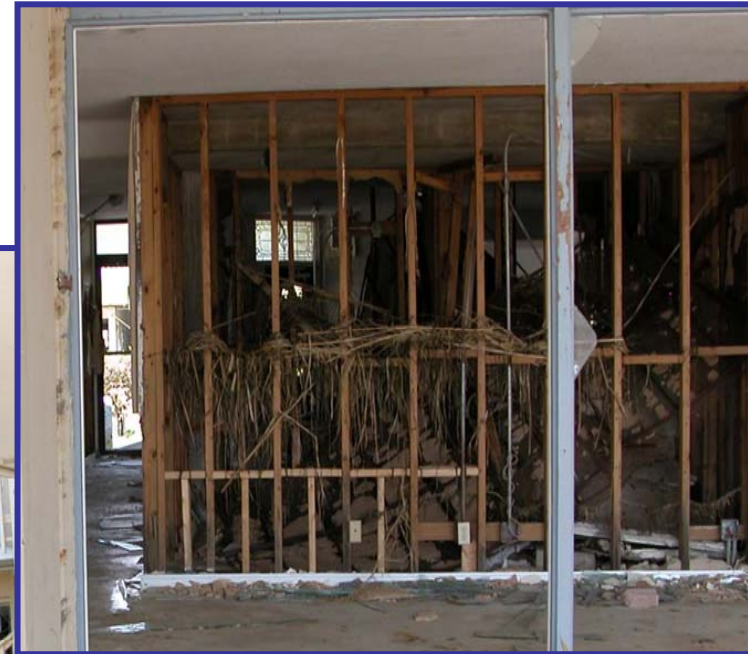
The removal of debris and the smell of decaying sea life will require a lot of hard work by those with strong stomachs!

**Notice the seaweed entangled in the electrical wires.**

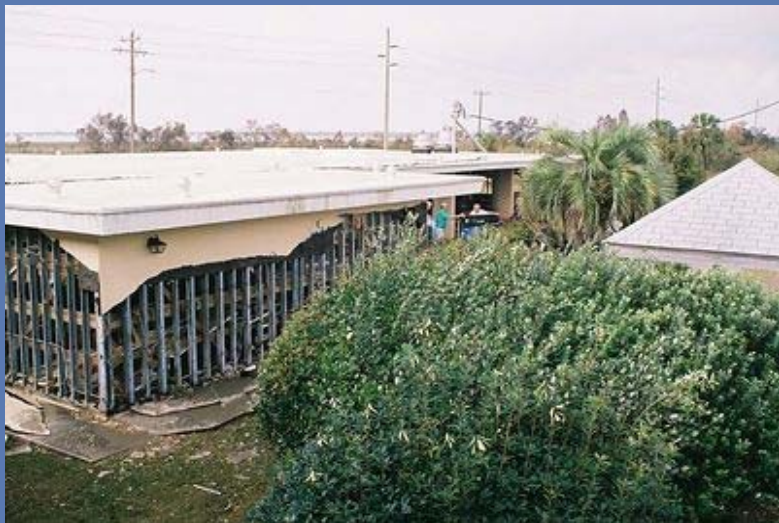
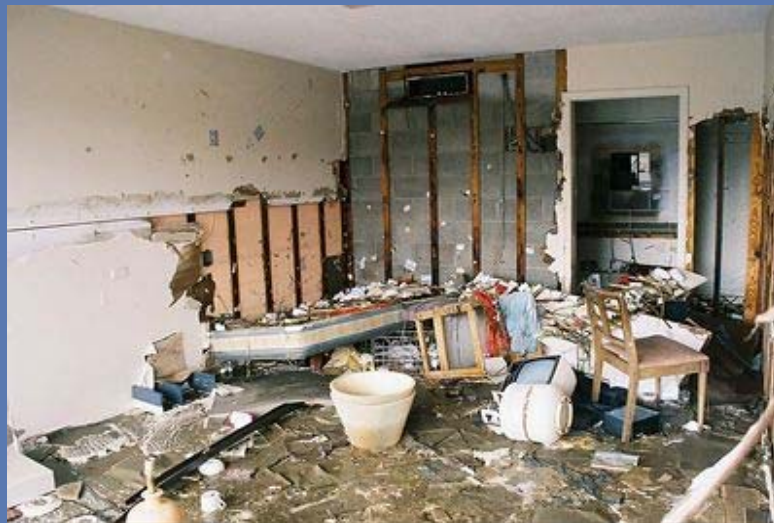
On August 29, 2005 the Shoulder was totally demolished as a direct result of Hurricane Katrina. [more photos](#)
