# *Hurricane Katrina – U.S. Gulf Coast – September, 2005*

## A photo tour of Hurricane Katrina

2001 Co. Wind Vented Roof System survives  
Hurricane Katrina winds and tidal surge.

**The Shoulder, Spanish Fort, Alabama**

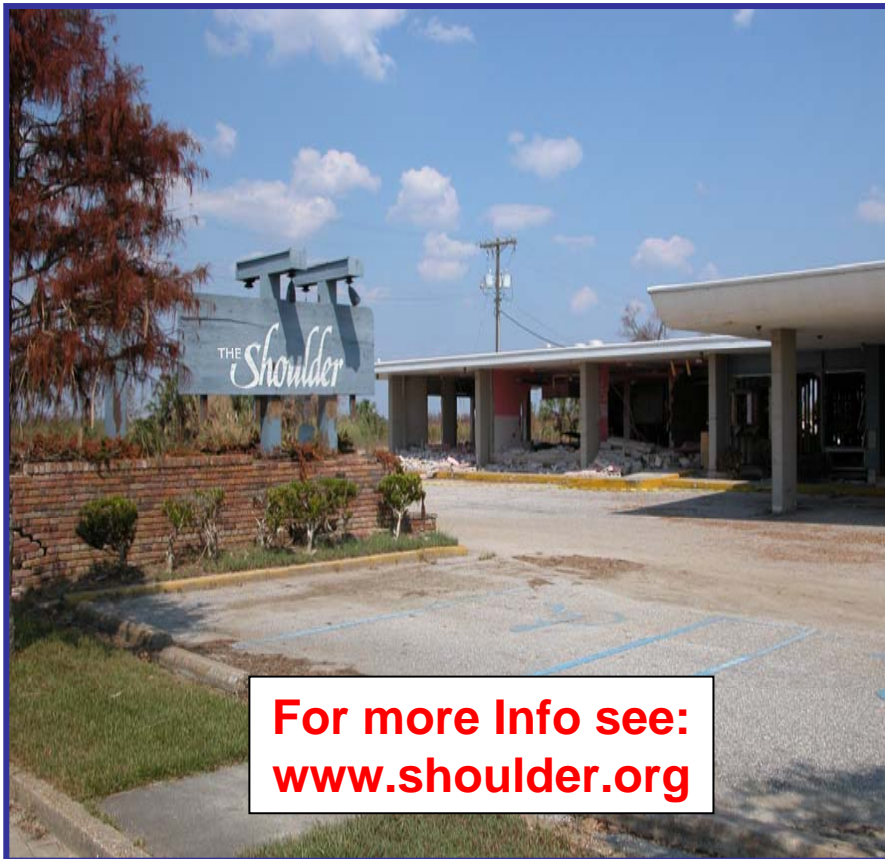
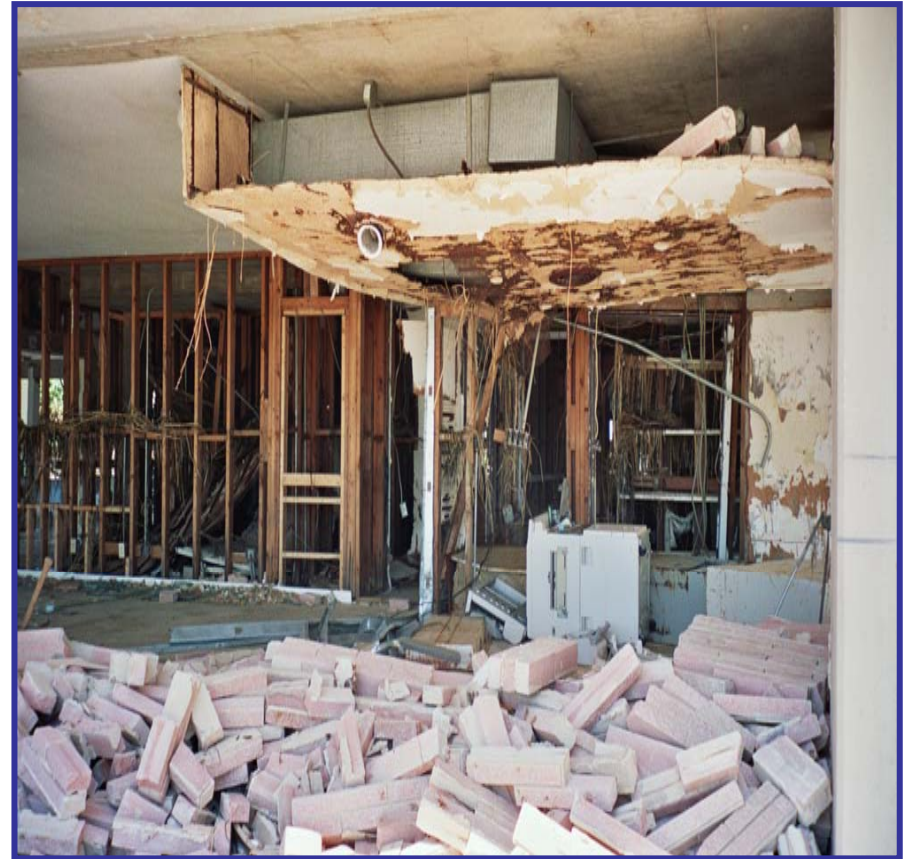
“**The Shoulder**” - a substance abuse treatment facility in Spanish Fort, AL with a **2001 Wind Vented Roof Assembly**. Built on a causeway, at the Northeast end of Mobile Bay, the building experienced “Hurricane Katrina’s” wind and tidal surge.

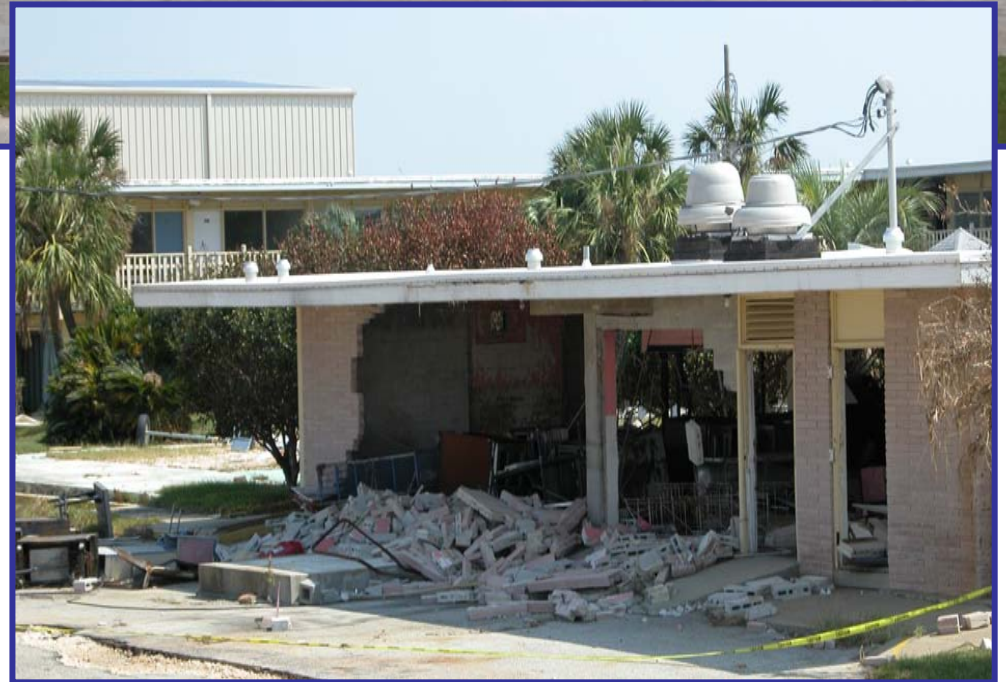
Experienced wind and tidal surge, Aug. 29<sup>th</sup>, 2005, but the 2001 Co. Wind Vented Roof stayed in place.

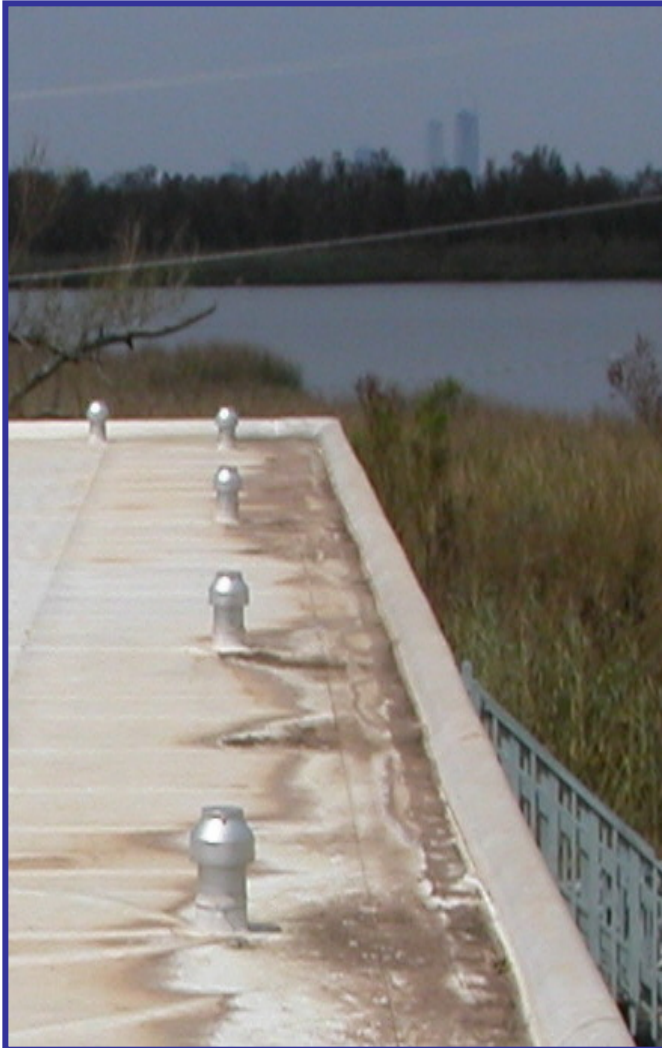
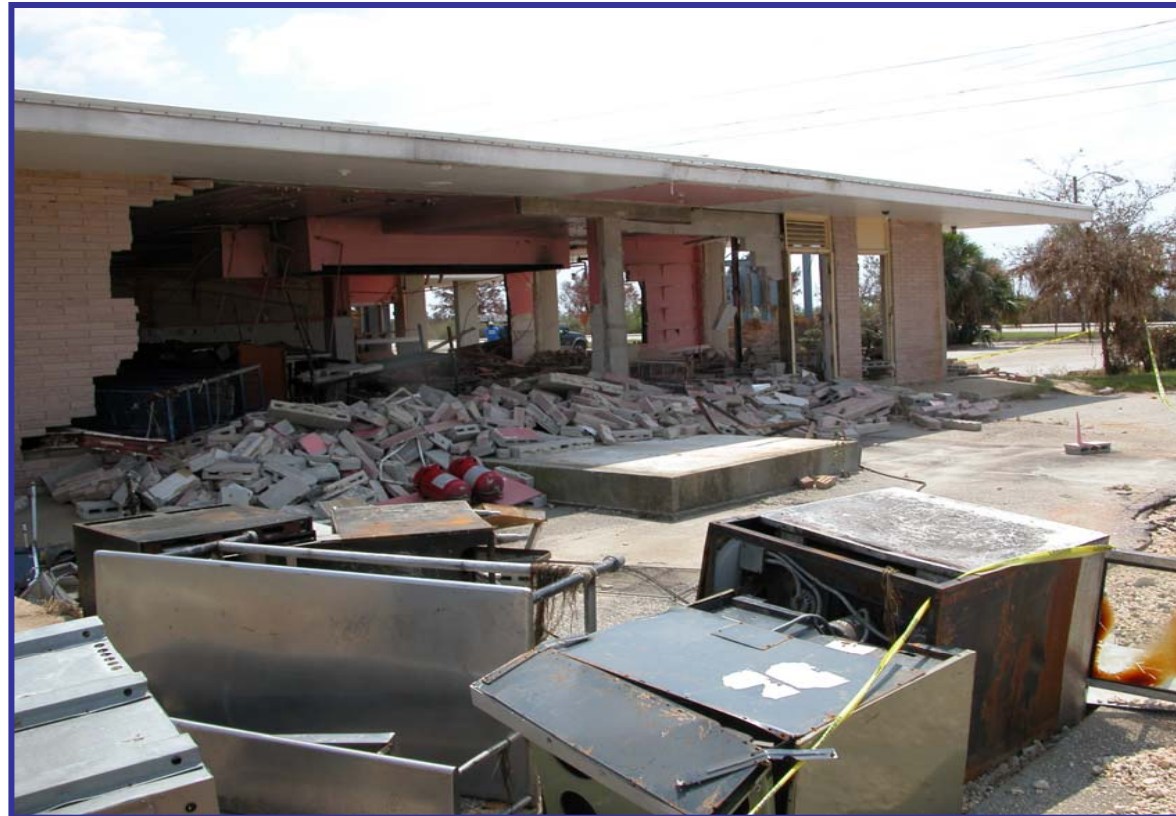
A combination of hurricane winds and tidal surge damaged the building interior and flushed appliances out of the building.

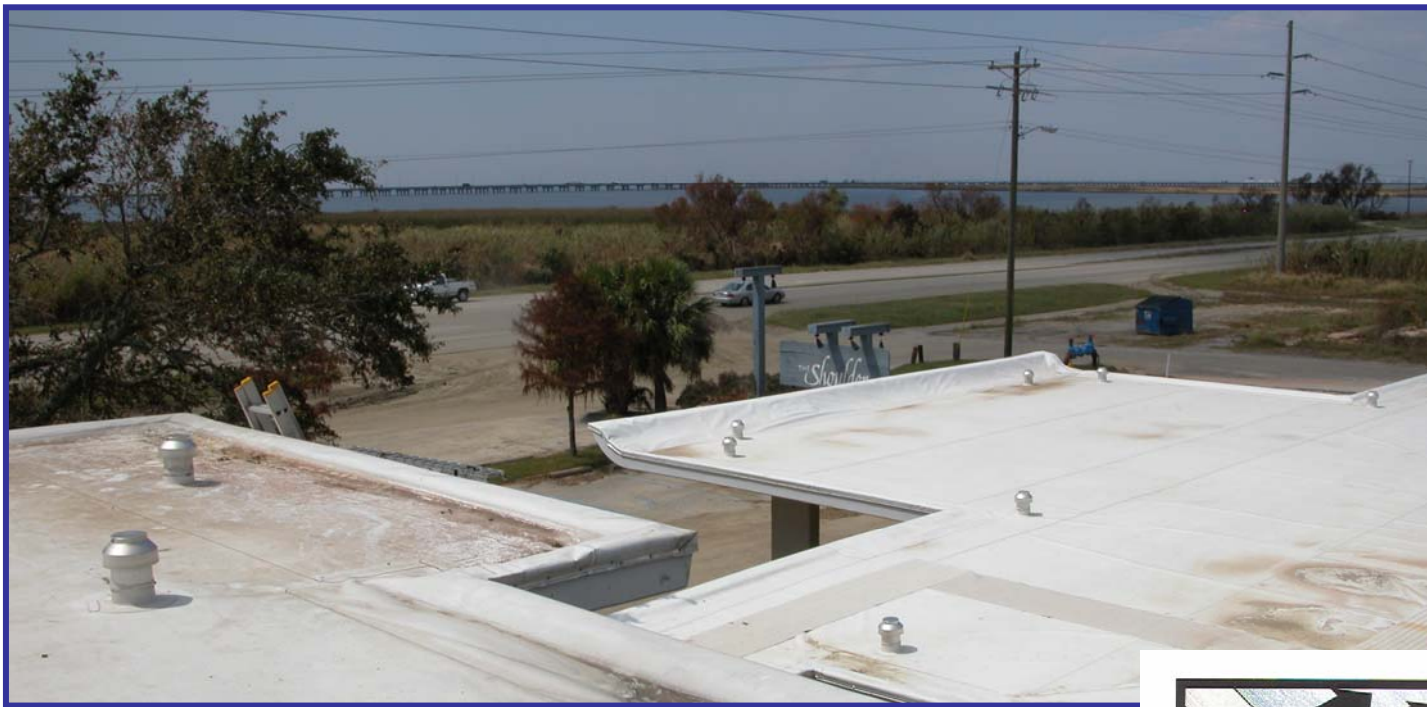
**Patented Equalizer Valves are strategically placed in wind generated vacuum intensity regions to equalize the pressure over and under the roof membrane**

**When wind flows over a building, it creates a vacuum uplift pressure above the roof. The 2001 Co. patented technology utilizes this vacuum pressure to vacuum pack the roof membrane to the roof deck.**

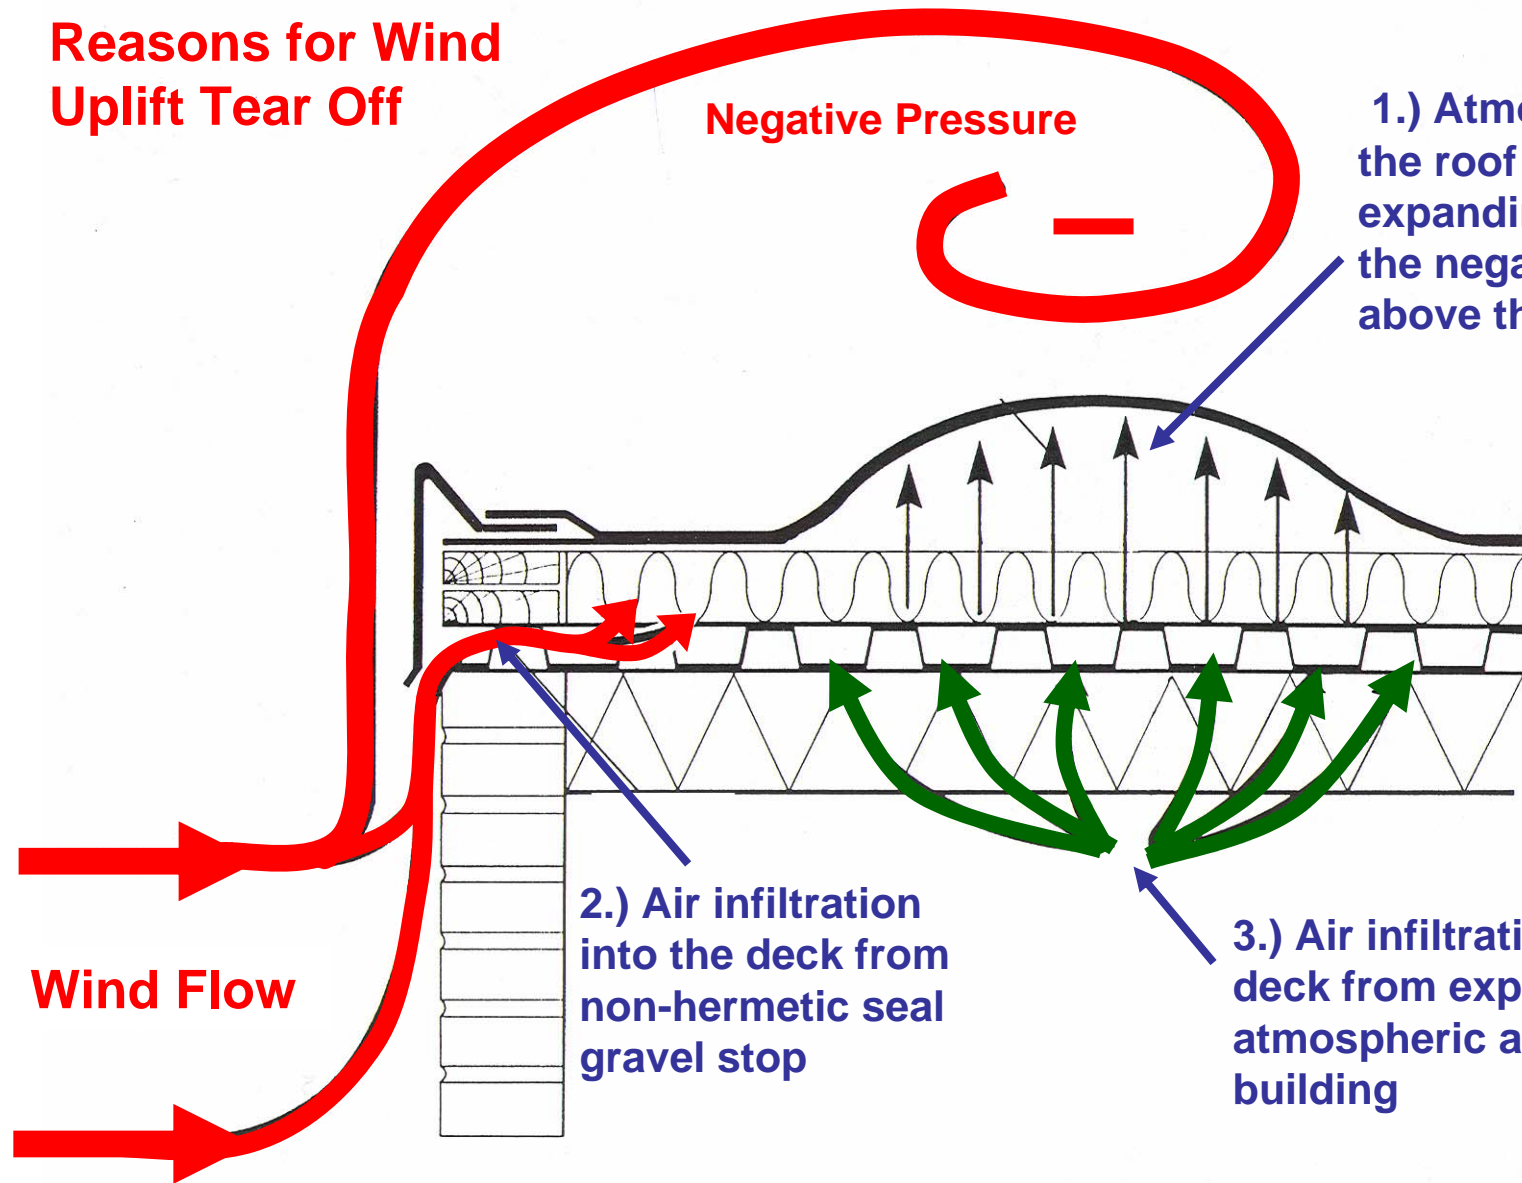
Negative Pressure

1.) Atmospheric air under the roof membrane is expanding to equalize to the negative pressure above the roof membrane

2.) Air infiltration into the deck from non-hermetic seal gravel stop

3.) Air infiltration into the deck from expansion of atmospheric air inside building

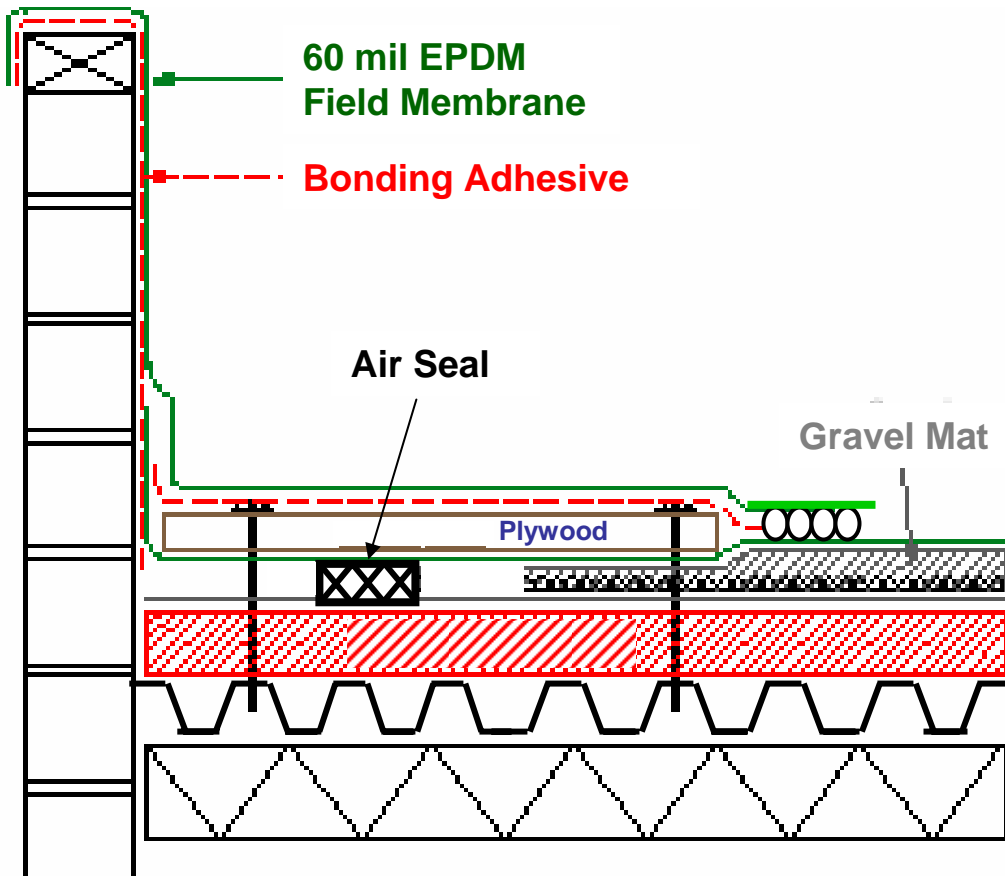
## Hurricane-Resistant Roof Waterproofing Membrane Edge termination technique, encapsulating a plywood board

**First** – Air is sealed at the deck level preventing air flow from beneath the deck and under the membrane.

**Second** – Air is sealed at the roof perimeter edge and at any penetrations with direct membrane termination to the deck

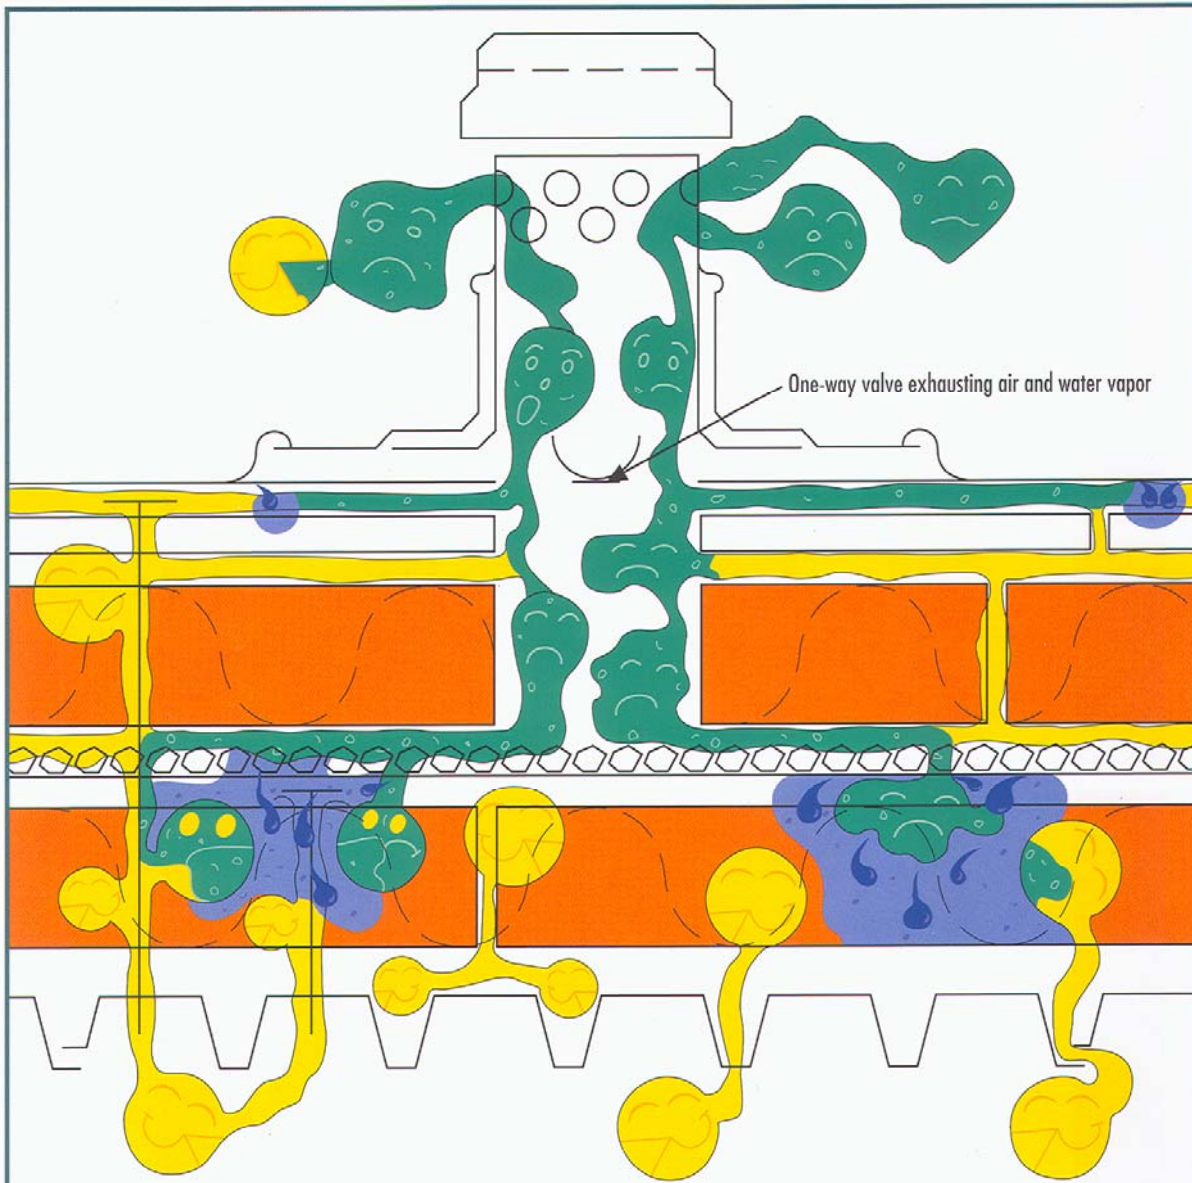
**Equalizer valves on the windward side of the building suck air out from under the roof membrane, while the valves on the leeward side allow a slight intake of air.**

**This patented equalizer valve controlled air exchange keeps a low sloped roof assembly dry, in the same way that air exchange between eave louvers and ridge vents keep residential peaked roofs dry.**
